Guardian Housing Services Ltd

Job Ref: 4212

24th July 2020

RE: SAFE AND SANITARY REPORT ADDRESSING THE REMOVAL OF A WALL WITHIN THE DWELLING LOCATED AT 3/142 ROSEBANK ROAD, AVONDALE.

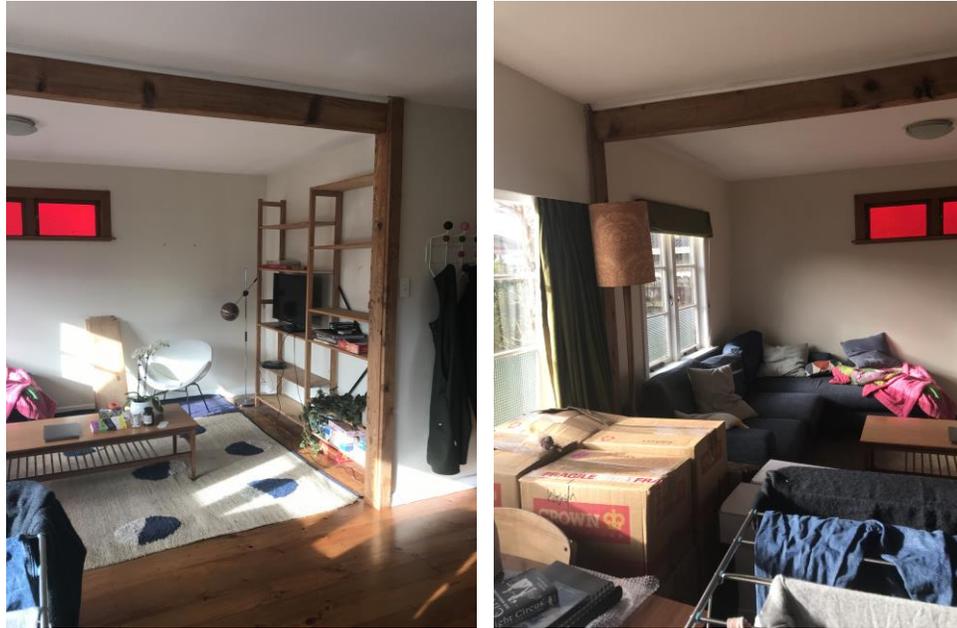
- 3.2 A plan on the council file shows that the dwelling initially consisted of two bedrooms. At some point in time a wall that separated the bedroom from the living area was removed and an exposed timber beam has been installed in its place.

- 3.3 We are of the advice that as best as can be established this work was undertaken either at the time of the relocation or shortly thereafter.
- 3.4 There is no visual evidence of any movement or settlement within this area as the result of the wall having been removed. There is a post that has been installed at both ends to transfer the loads to the foundation system of the dwelling.
